GROUNDWATER QUALITY ANALYSIS REPORT

Kampong Cham - Ou Reang Ov - Damrei (71F)

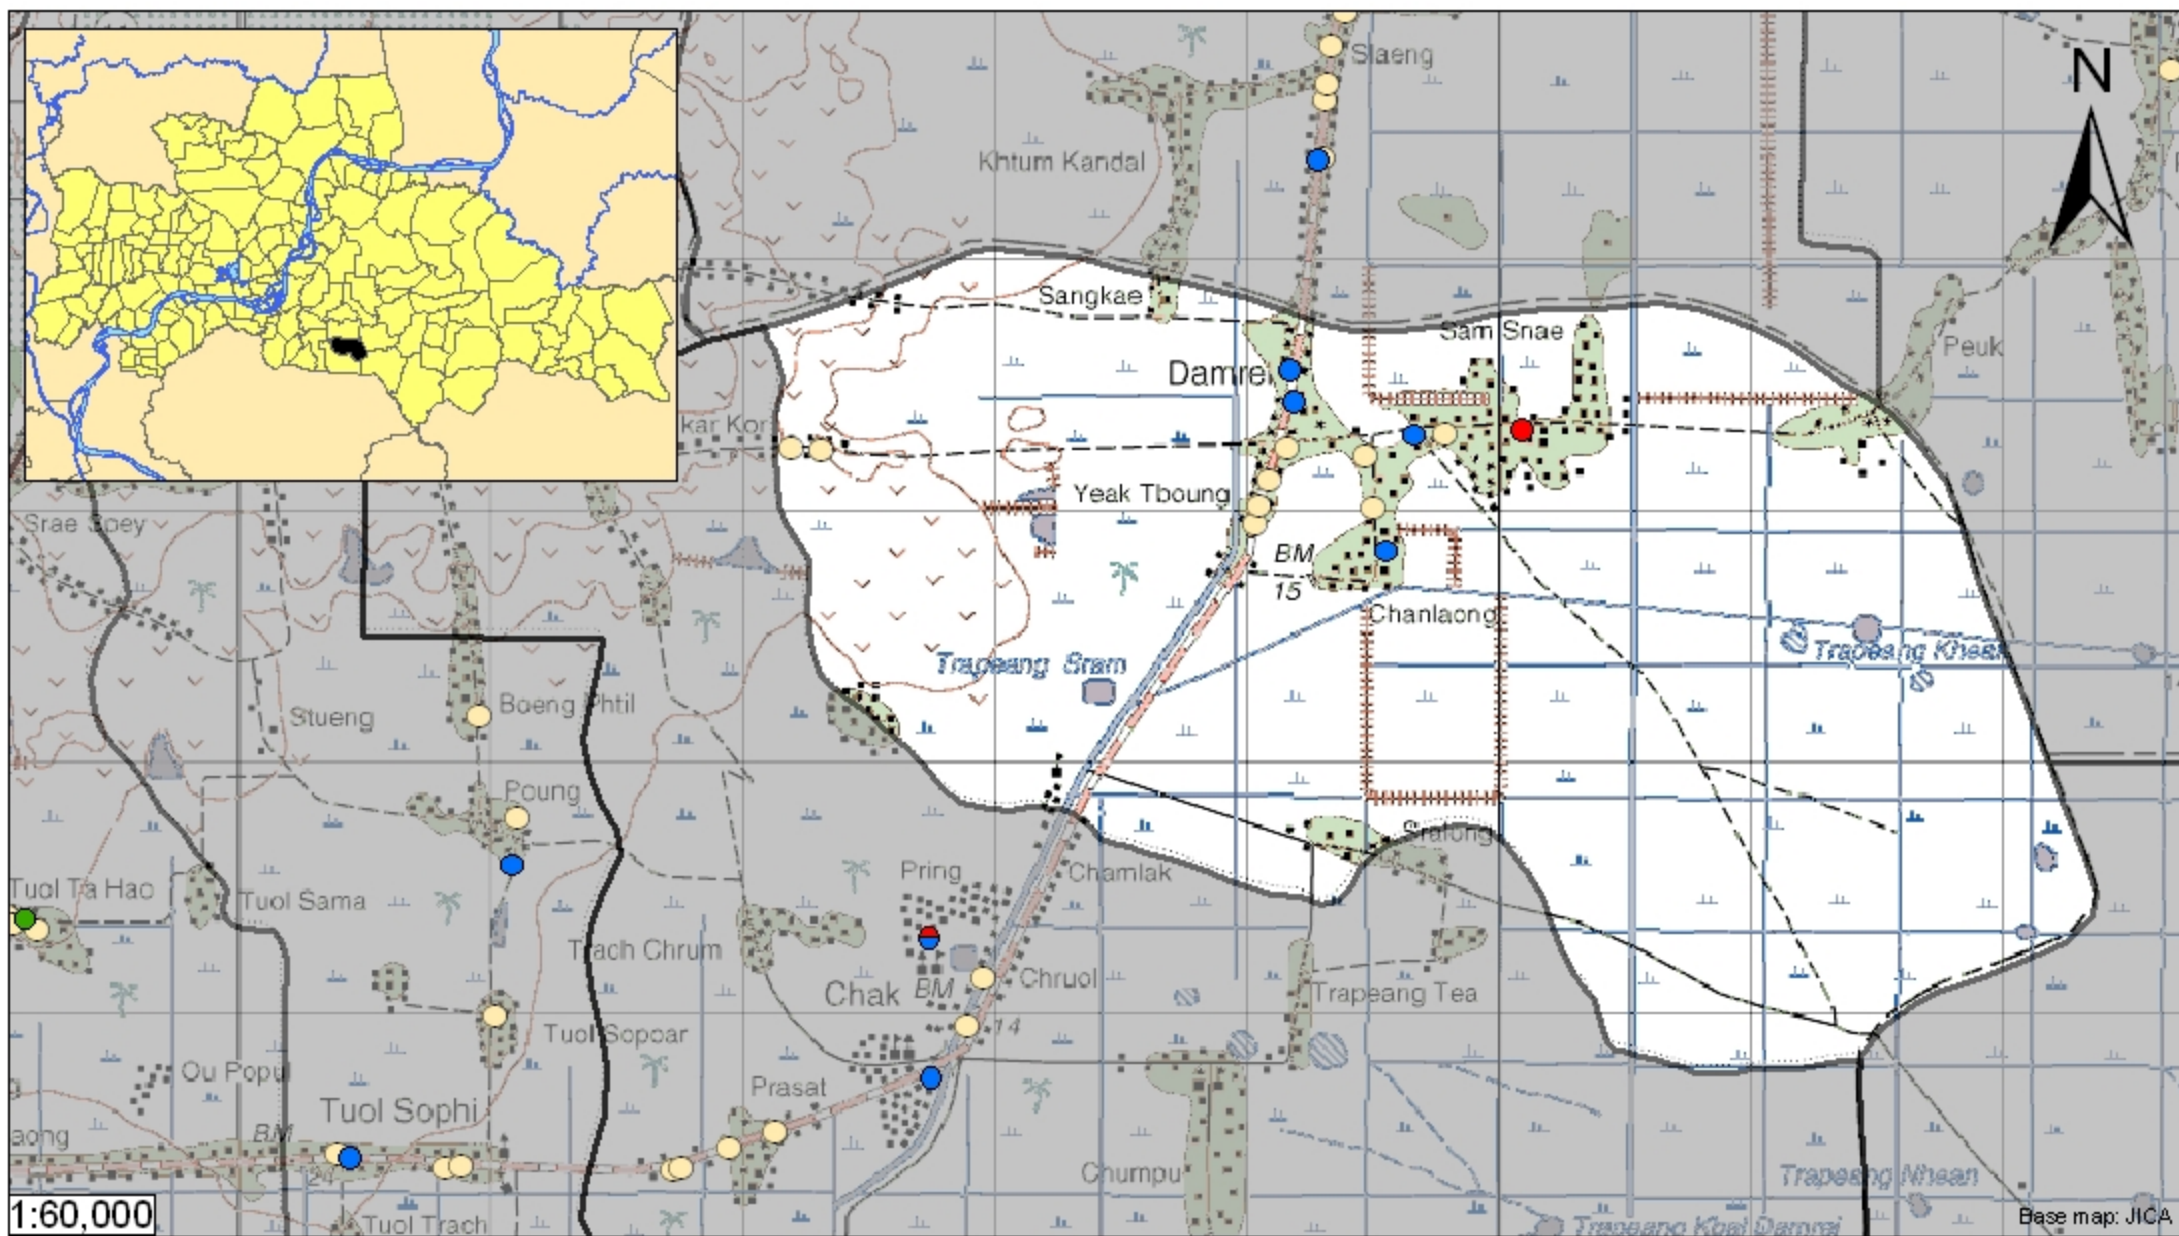
Tube Well Sample Locations and Health-Based Exceedances

Damrei is located in the district of Ou Reang Ov. The population of this commune is approximately 8679 (2004). Groundwater sample collection occurred in July 2008 and consisted of the sampling of 14 tube wells throughout the commune. The attached figure presents the location of Damrei within Kampong Cham as well as groundwater sample locations and exceedances of health-impacting contaminants (when applicable).

Arsenic - Elevated concentrations of Arsenic were observed within the commune. The estimated probability of encountering unacceptable concentrations of Arsenic (>50 ppb) in tube wells is 1%, based on the observed data. Long-term (5 to 10 year) exposure to elevated concentrations of Arsenic can cause arsenicosis (debilitating skin disease), increased risks of contracting cancer, as well as other negative health impacts.

Manganese - Elevated concentrations of Manganese were observed within the commune. The estimated probability of encountering unacceptable concentrations of Manganese (>0.4 mg/L) in tube wells is 22%, based on the observed data. Exposure to elevated concentrations of Manganese can cause neurological disorders. Aeration allows oxygen to enter the water and react with Manganese to form a compound which is insoluble in water. The newly formed solids will slowly settle to the bottom or can be removed more rapidly by filtration. Performing these procedures may reduce the concentration of Manganese in water but follow-up testing is recommended to ensure water quality standards are met.
