Tube Well Sample Locations and Health-Based Exceedances

Anhchanh Rung - Baribour - Kampong Chhnang - Cambodia

Resource Development International - Cambodia www.rdic.org

January 2011

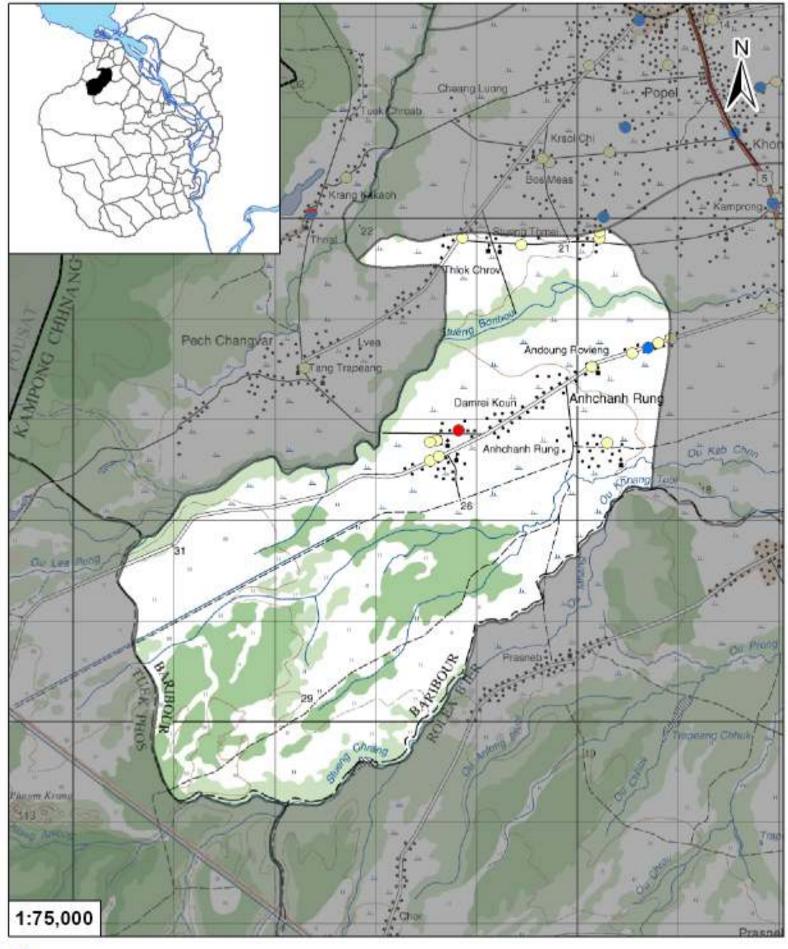
Anhchanh Rung is located in the district of Baribour. The population of this commune is approximately 4096 (2004). Groundwater sample collection occurred in March 2010 and consisted of the sampling of 16 tube wells throughout the commune. The attached figure presents the location of Anhchanh Rung within Kampong Chnang as well as groundwater sample locations and exceedances of health-impacting contaminants (when applicable).

Locations exceeding the Cambodian water quality standards for major health impacting contaminants have been color-coded and arranged such that they do not overlap
