## **GROUNDWATER QUALITY ANALYSIS REPORT**

# Tube Well Sample Locations and Health-Based Exceedances

Prey Puok - Angk Snuol - Kandal - Cambodia

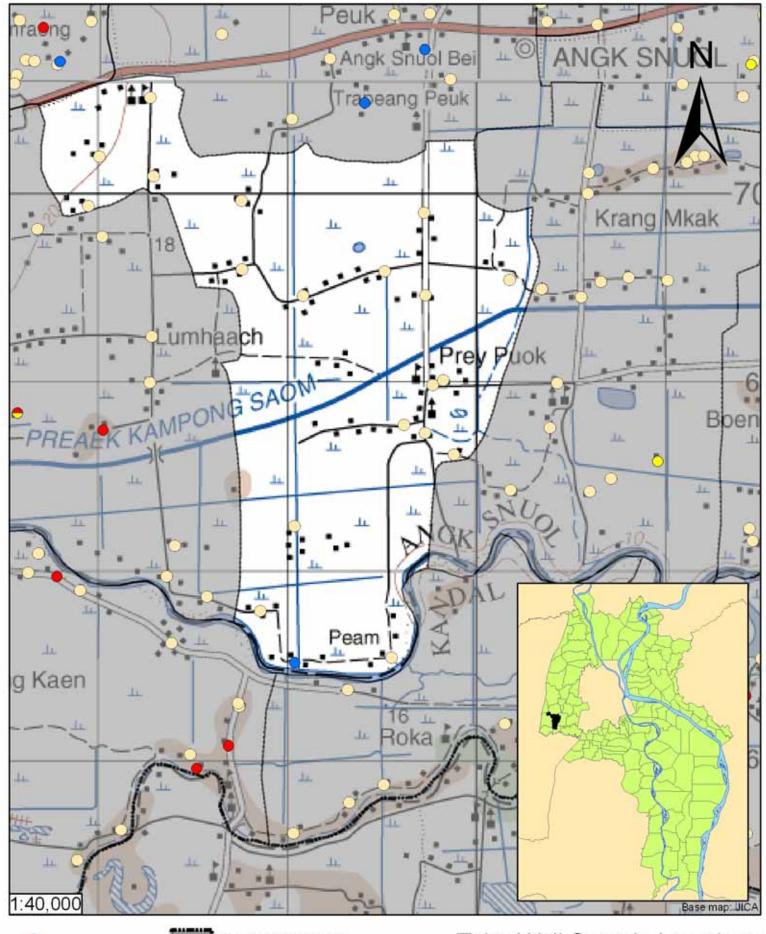
Prey Puok is located in the district of Angk Snuol. The population of this commune is approximately 5747 (2004). Groundwater sample collection occurred in November 2006 and consisted of the sampling of 20 tube wells throughout the commune. The attached figure presents the location of Prey Puok within Kandal as well as groundwater sample locations and exceedances of health-impacting contaminants (when applicable).

Fluoride Locations exceeding the
Cambodian water quality
standards for major healthimpacting contaminants have
been colour-coded and arranged
No Exceedance such that they do not overlap.
