# GROUNDWATER QUALITY ANALYSIS REPORT

## *Kandal - Kien Svay - Banteay Daek (1F)*

## Tube Well Sample Locations and Health-Based Exceedances

*Banteay Daek - Kien Svay - Kandal - Cambodia*

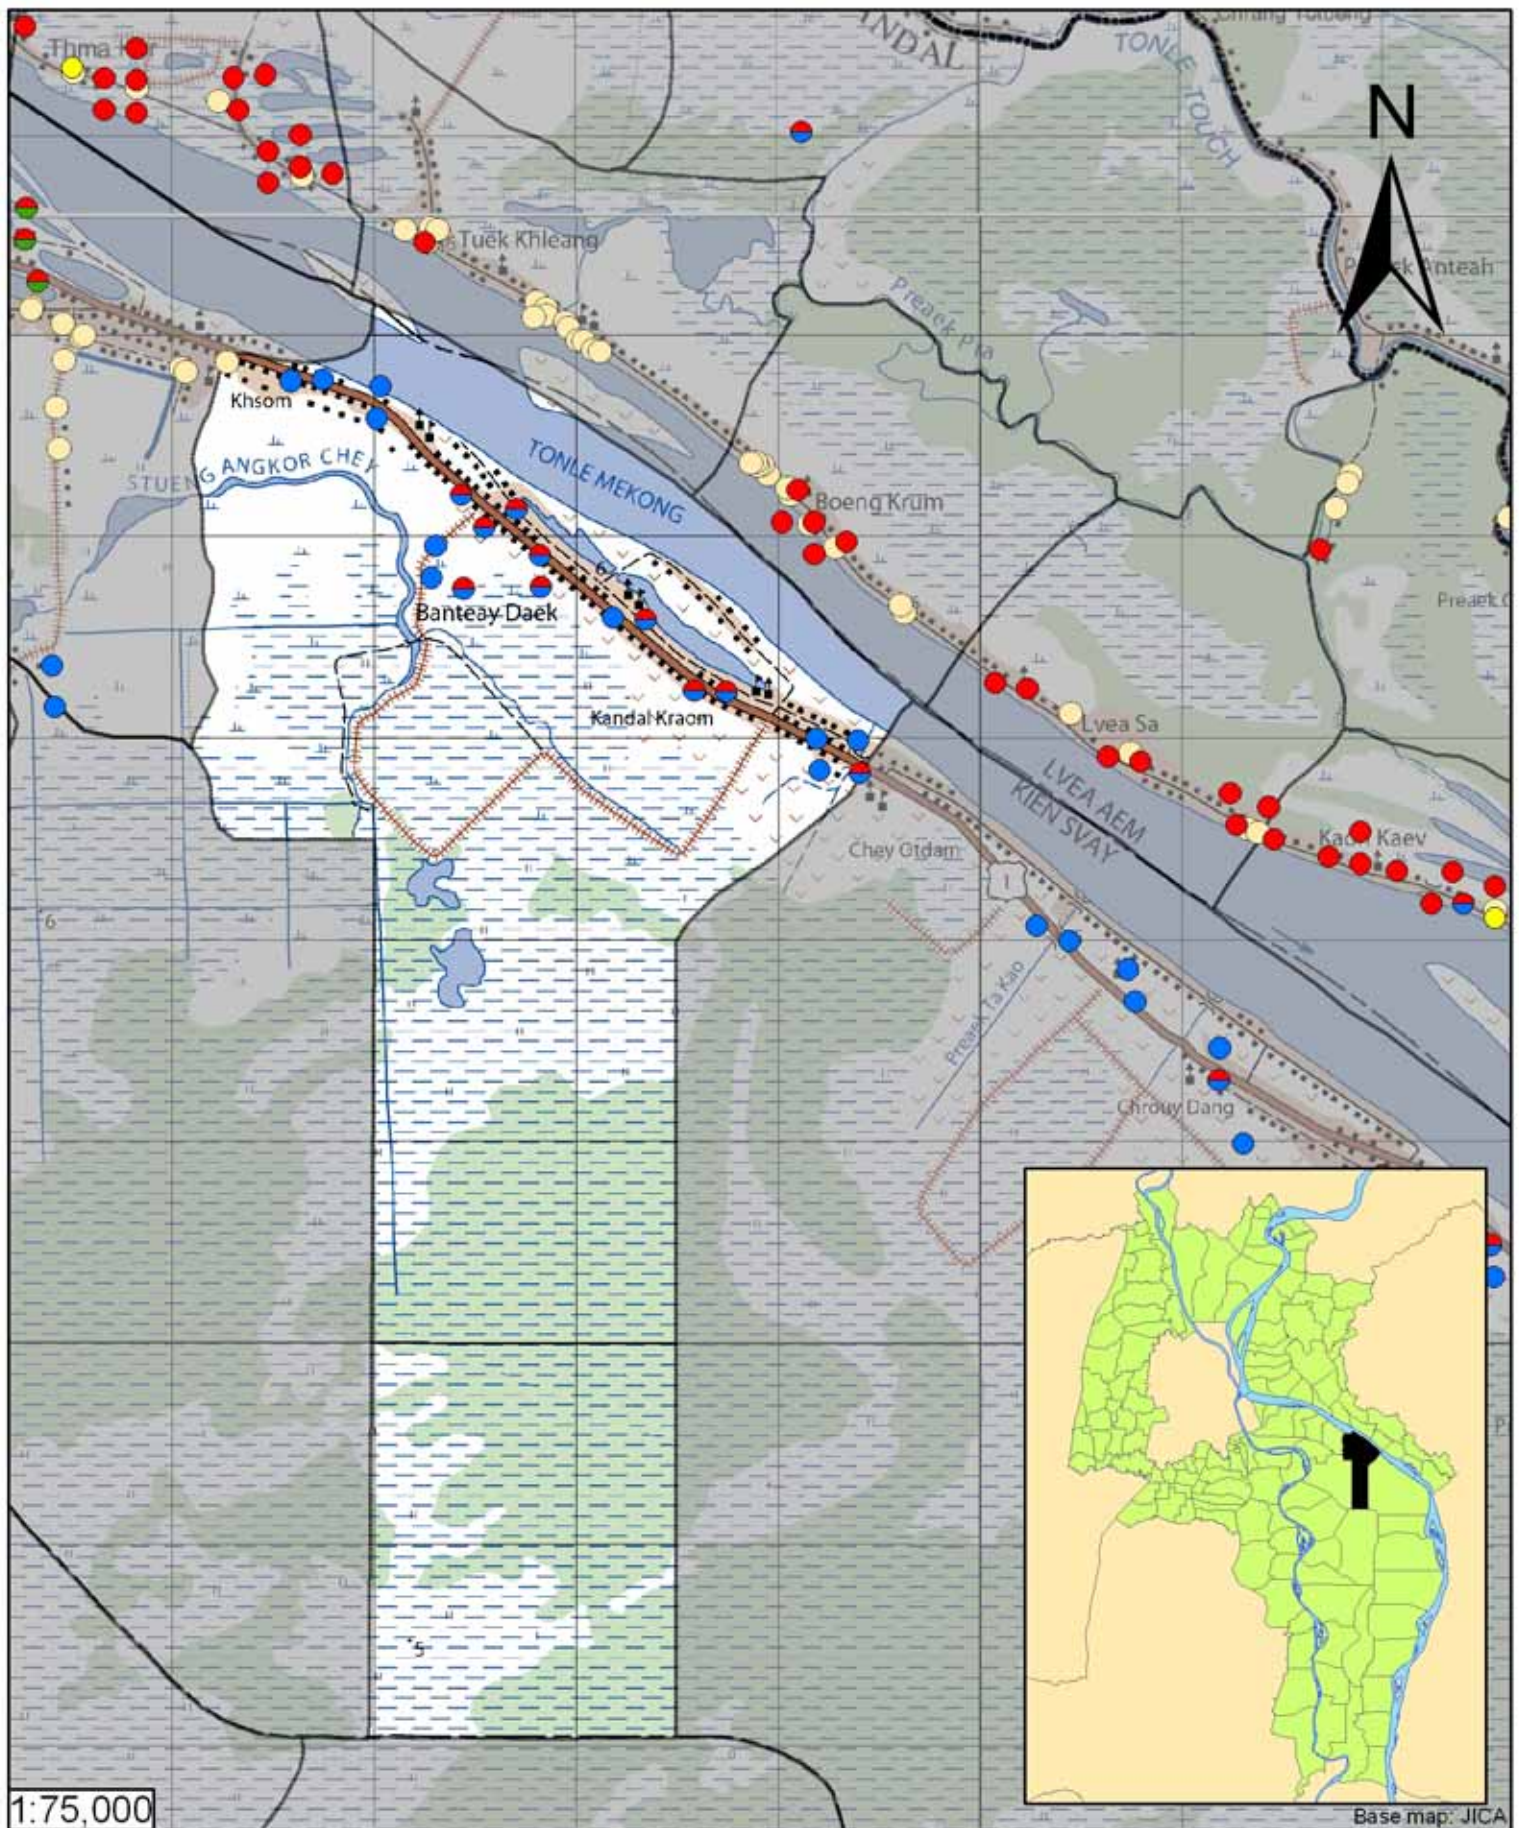
Banteay Daek is located in the district of Kien Svay. The population of this commune is approximately 12353 (2004). Groundwater sample collection occurred in September 2005 and consisted of the sampling of 20 tube wells throughout the commune. The attached figure presents the location of Banteay Daek within Kandal as well as groundwater sample locations and exceedances of health-impacting contaminants (when applicable).

**Arsenic** - Elevated concentrations of Arsenic were observed within the commune. The estimated probability of encountering unacceptable concentrations of Arsenic (>50 ppb) in tube wells is 64%, based on the observed data. Long-term (5 to 10 year) exposure to elevated concentrations of Arsenic can cause arsenicosis (debilitating skin disease), increased risks of contracting cancer, as well as other negative health impacts.

**Manganese** - Elevated concentrations of Manganese were observed within the commune. The estimated probability of encountering unacceptable concentrations of Manganese (>0.4 mg/L) in tube wells is 100%, based on the observed data. Exposure to elevated concentrations of Manganese can cause neurological disorders. Aeration allows oxygen to enter the water and react with Manganese to form a compound which is insoluble in water. The newly formed solids will slowly settle to the bottom or can be removed more rapidly by filtration. Performing these procedures may reduce the concentration of Manganese in water but follow-up testing is recommended to ensure water quality standards are met.

- Arsenic
- Manganese
- Fluoride
- Nitrate
- No Exceedance
- Provincial Boundary
- Commune Boundary
- Locations exceeding the Cambodian water quality standards for major health-impacting contaminants have been colour-coded and arranged such that they do not overlap.
