GROUNDWATER QUALITY ANALYSIS REPORT

Kampong Cham - Kampong Siem - Srak (33F)

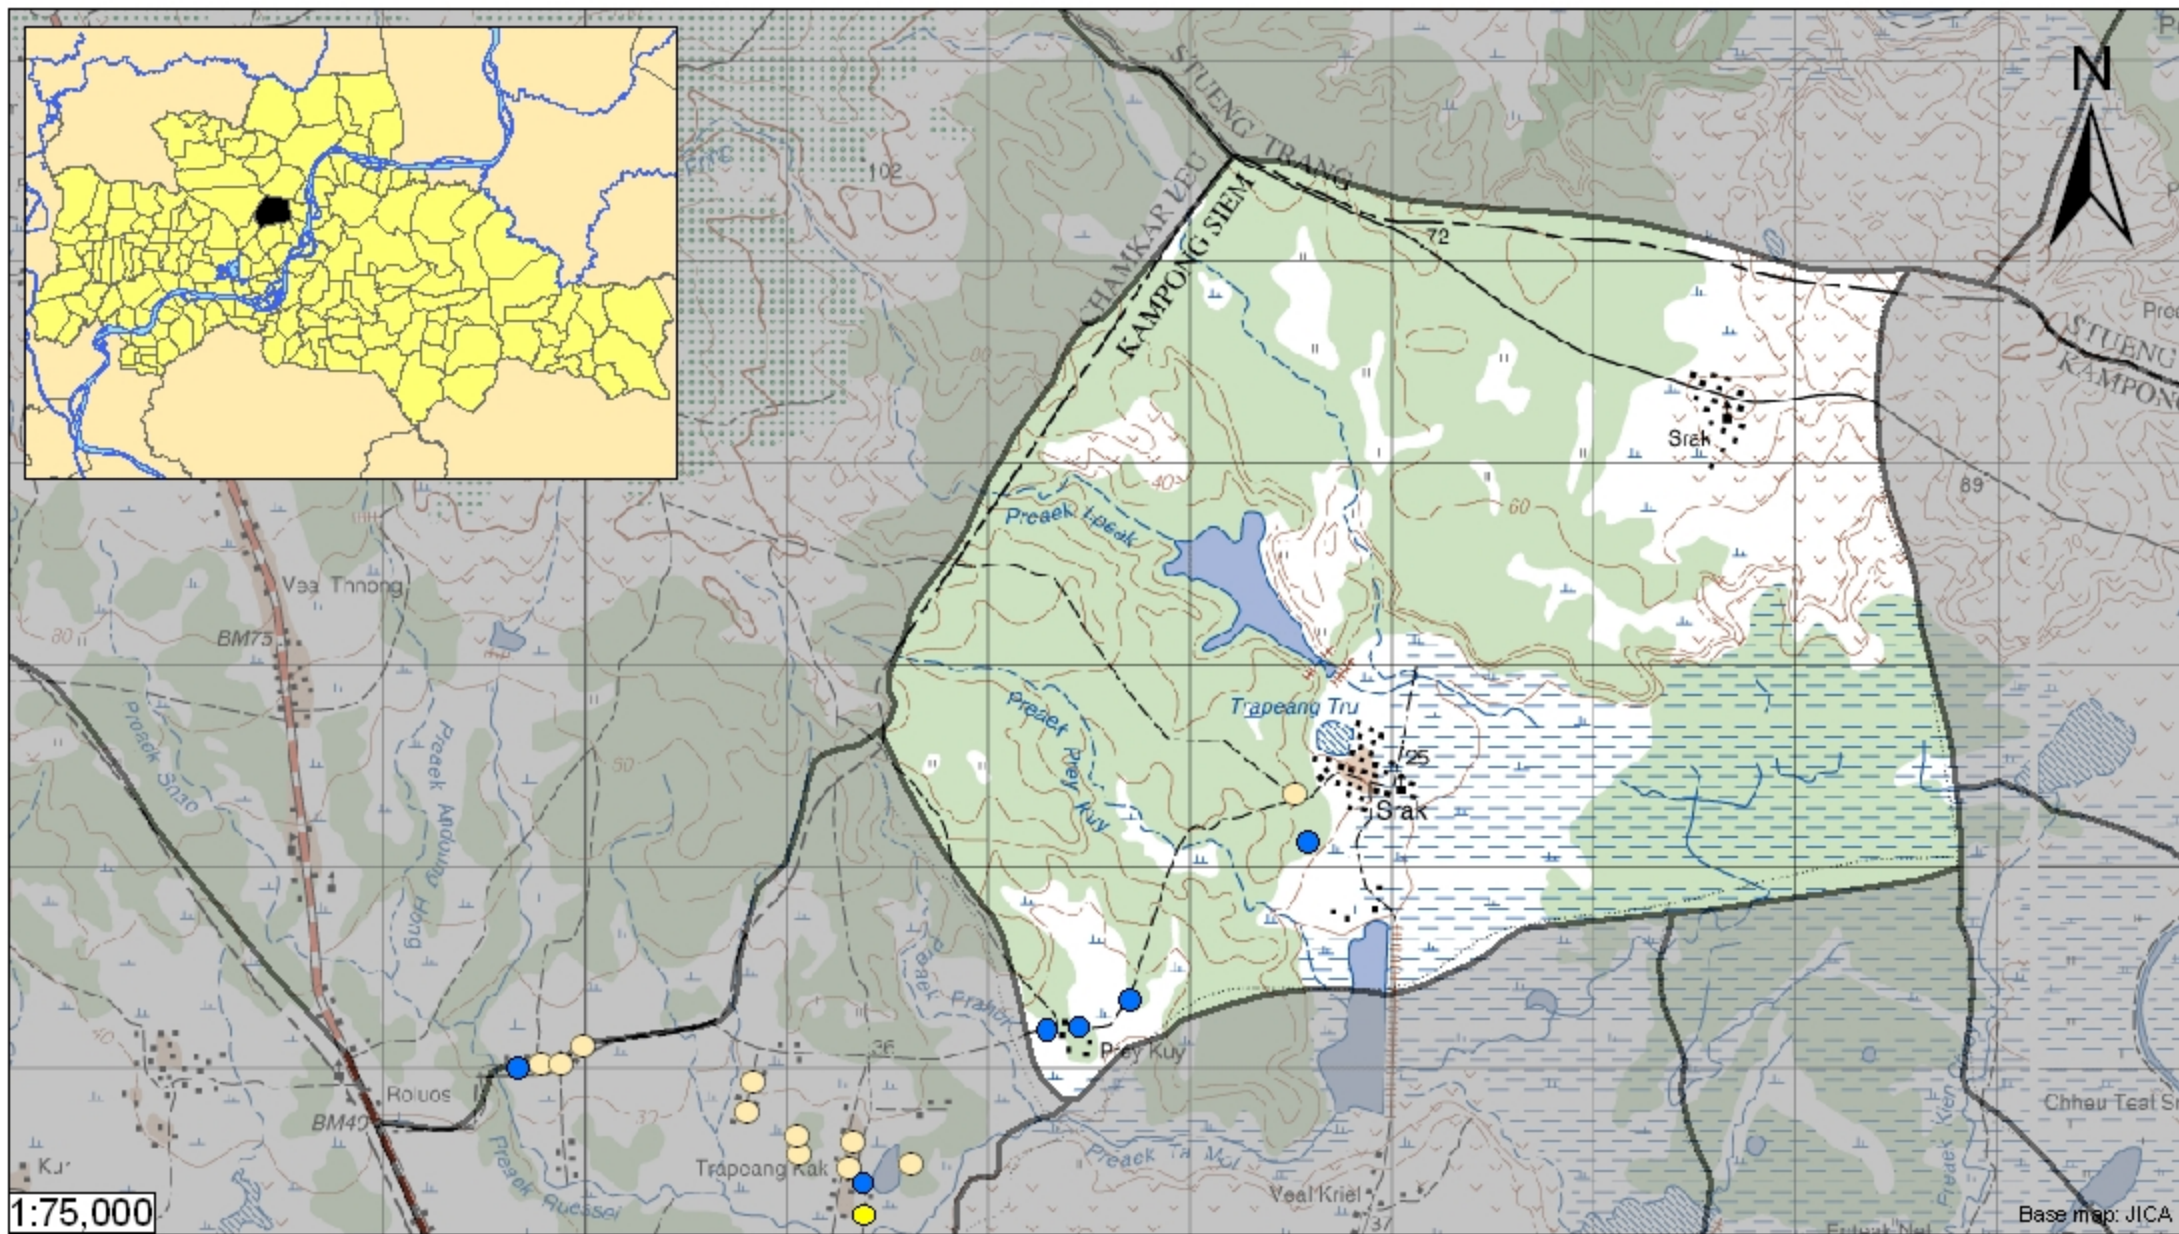
Tube Well Sample Locations and Health-Based Exceedances

Srak is located in the district of Kampong Siem. The population of this commune is approximately 5137 (2004). Groundwater sample collection occurred in June 2008 and consisted of the sampling of 5 tube wells throughout the commune. The attached figure presents the location of Srak within Kampong Cham as well as groundwater sample locations and exceedances of health-impacting contaminants (when applicable).

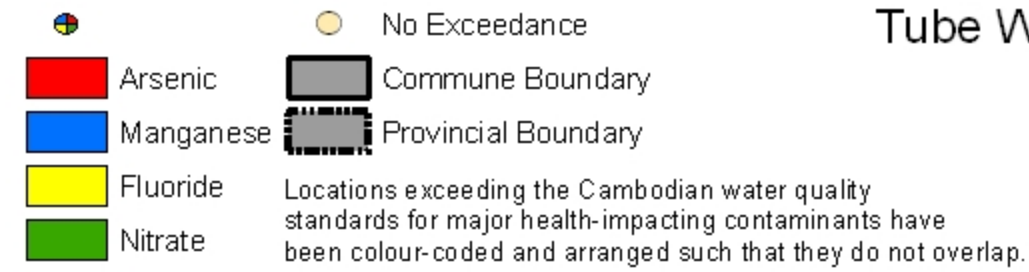
Srak - Kampong Siem - Kampong Cham - Cambodia
