# GROUNDWATER QUALITY ANALYSIS REPORT

## *Kampong Cham - Memot - Tramung (87F)*

## Tube Well Sample Locations and Health-Based Exceedances

*Tramung - Memot - Kampong Cham - Cambodia*

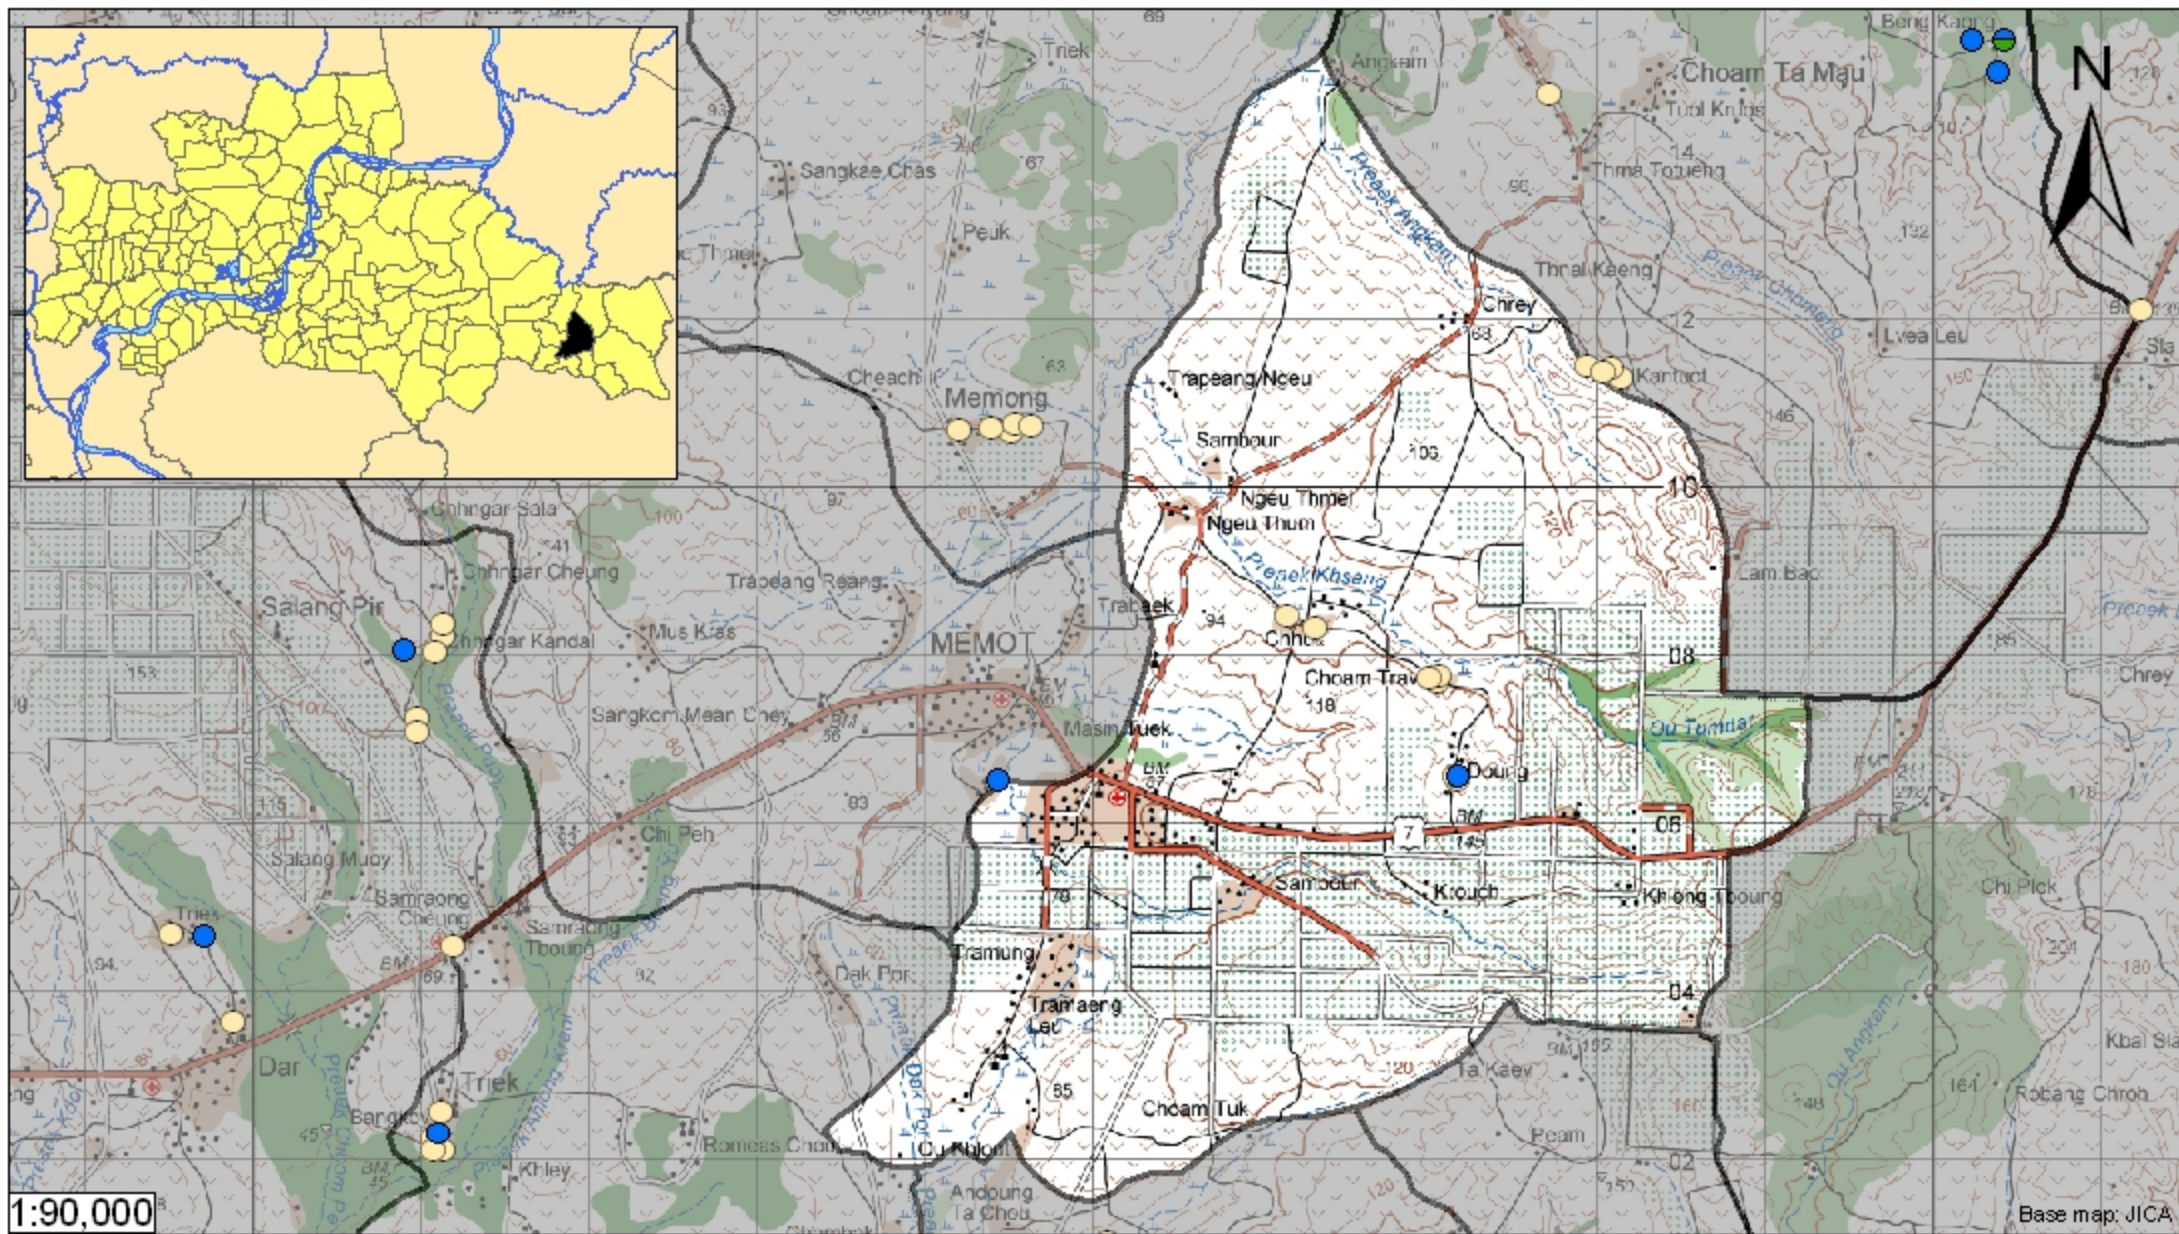
Tramung is located in the district of Memot. The population of this commune is approximately 12214 (2004). Groundwater sample collection occurred in October 2008 and consisted of the sampling of 8 tube wells throughout the commune. The attached figure presents the location of Tramung within Kampong Cham as well as groundwater sample locations and exceedances of health-impacting contaminants (when applicable).
