GROUNDWATER QUALITY ANALYSIS REPORT

Kampong Cham - Tboung Khmum - Lngieng (60F)

Tube Well Sample Locations and Health-Based Exceedances

Lngieng - Tboung Khmum - Kampong Cham - Cambodia

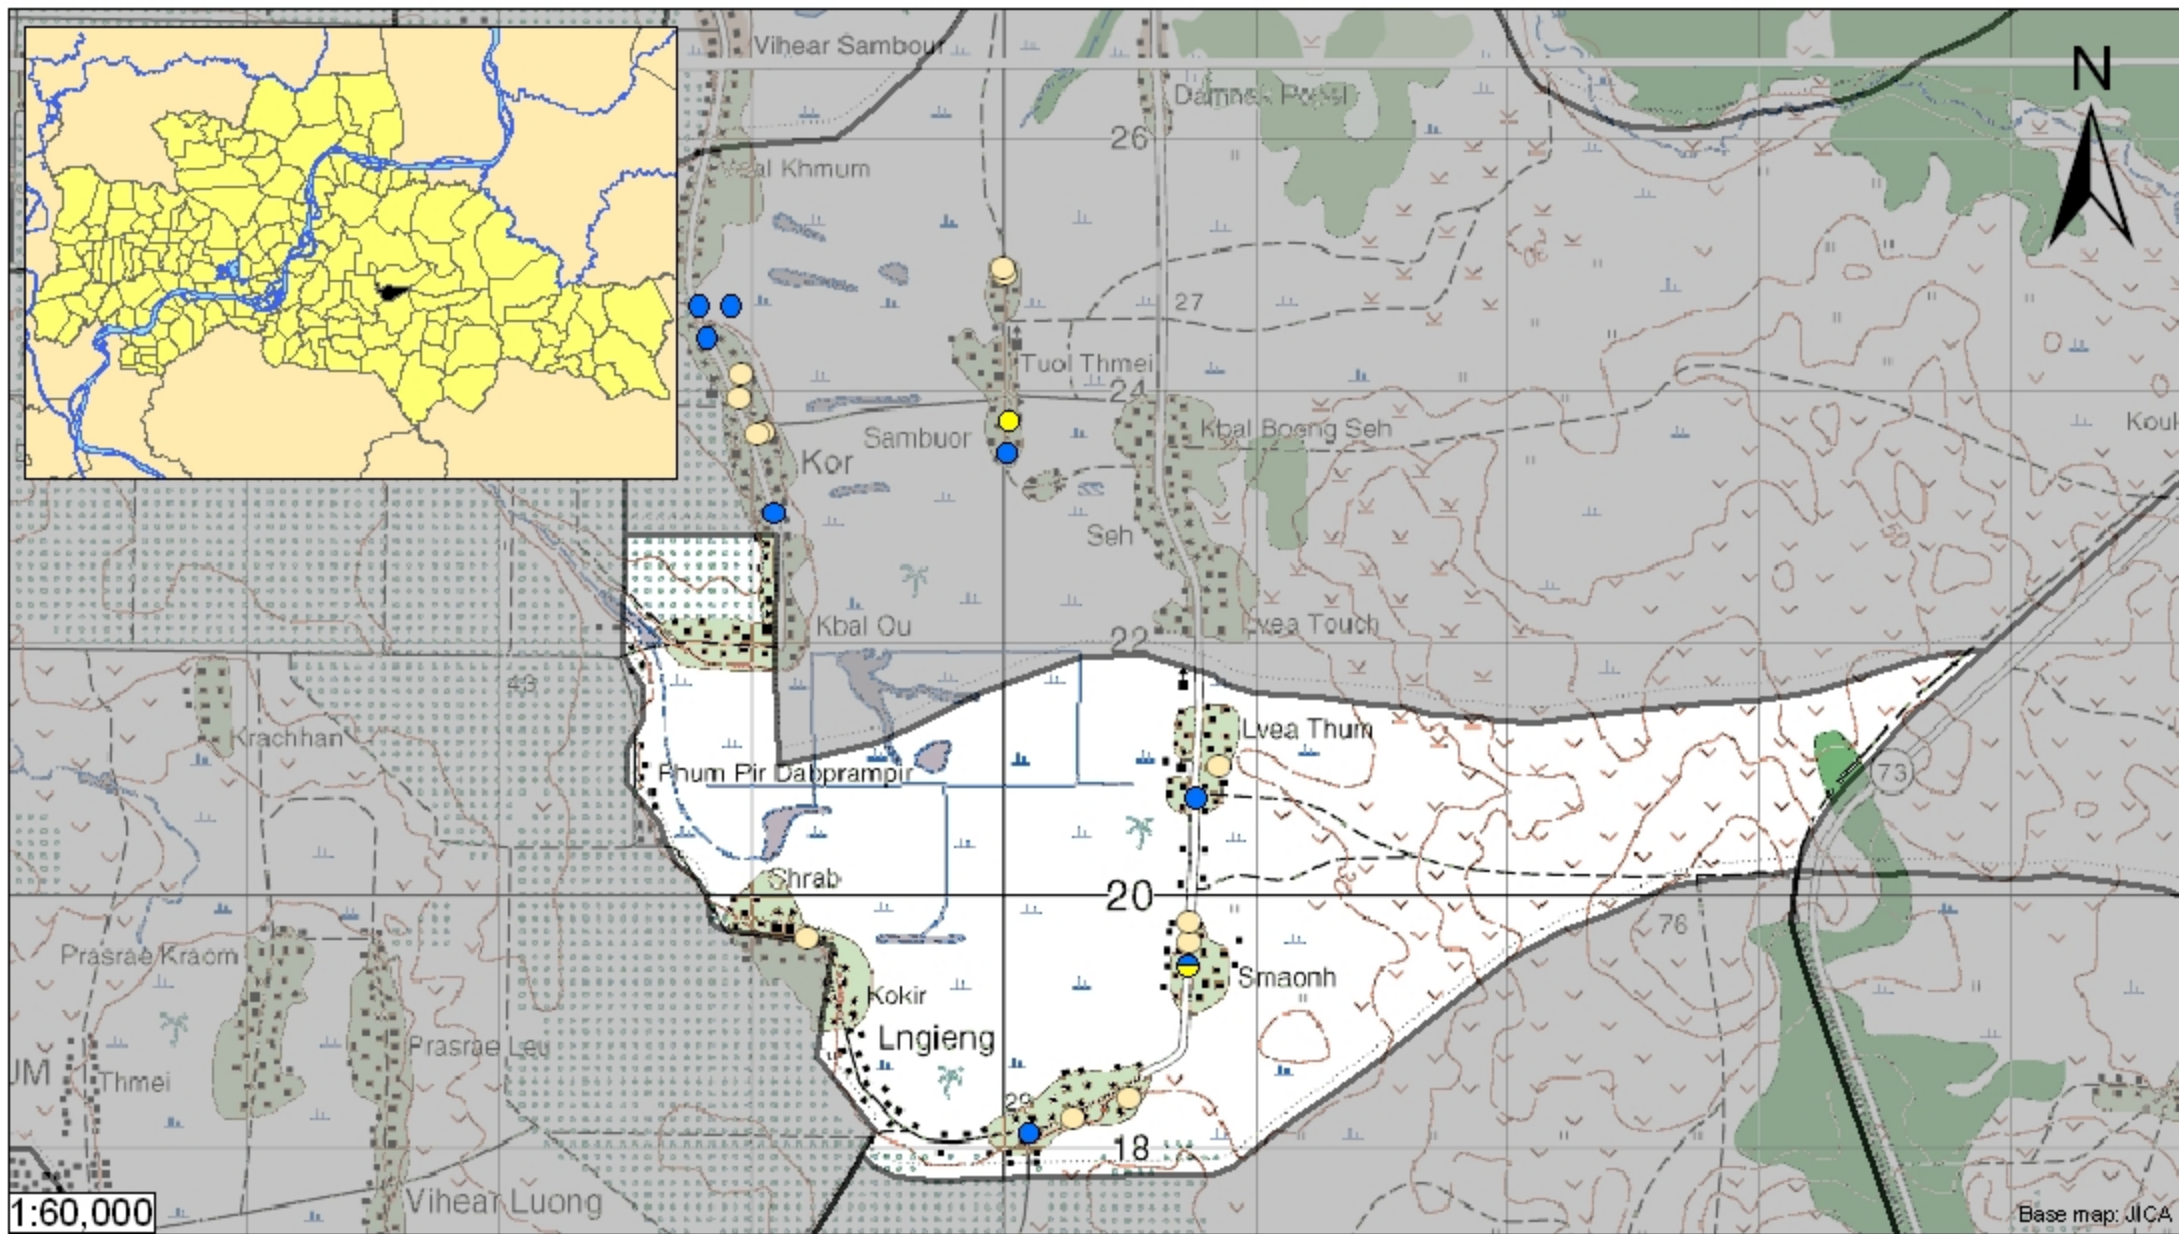
Lngieng is located in the district of Tboung Khmum. The population of this commune is approximately 6320 (2004). Groundwater sample collection occurred in July 2008 and consisted of the sampling of 9 tube wells throughout the commune. The attached figure presents the location of Lngieng within Kampong Cham as well as groundwater sample locations and exceedances of health-impacting contaminants (when applicable).

Manganese - Elevated concentrations of Manganese were observed within the commune. The estimated probability of encountering unacceptable concentrations of Manganese (>0.4 mg/L) in tube wells is 34%, based on the observed data. Exposure to elevated concentrations of Manganese can cause neurological disorders. Aeration allows oxygen to enter the water and react with Manganese to form a compound which is insoluble in water. The newly formed solids will slowly settle to the bottom or can be removed more rapidly by filtration. Performing these procedures may reduce the concentration of Manganese in water but follow-up testing is recommended to ensure water quality standards are met.

Fluoride - Elevated concentrations of Fluoride were observed within the commune. The estimated probability of encountering unacceptable concentrations of Fluoride (>1.5 mg/L) in tube wells is 21%, based on the observed data. At concentrations greater than 1.5 mg/L, Fluoride can cause dental fluorosis and at concentrations greater than 4 mg/L, skeletal fluorosis can occur.

Provincial Boundary
- Locations exceeding the Cambodian water quality standards for major health-impacting contaminants have been colour-coded and arranged such that they do not overlap.
